0 329 085
A1

EUROPEAN PATENT APPLICATION

(54) Heat treated chemically vapor deposited products and treatment method.

HEAT TREATED CHEMICALLY VAPOR DEPOSITED PRODUCTS AND TREATMENT METHOD

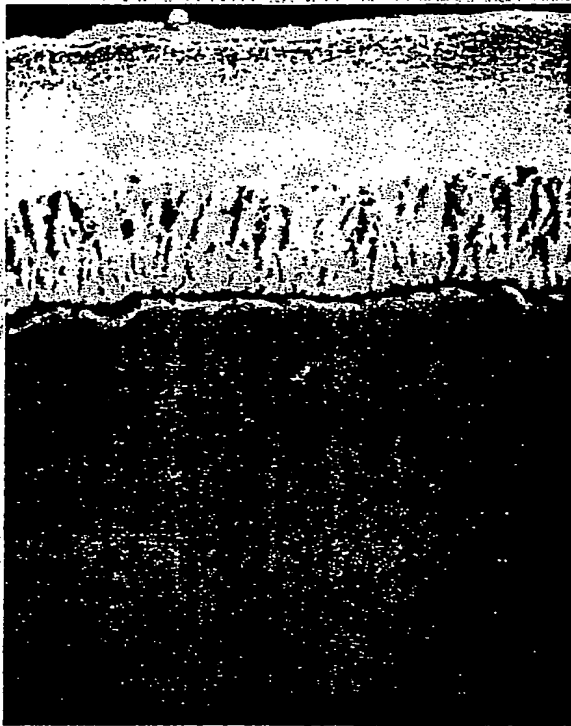
FIG. 1A

10 Figure 1A is a photomicrograph, magnified 2000 times, of an etched cross section of a coating system according to the invention on AM-350 stainless steel substrate in the as-deposited and unheat-treated condition showing non-uniform microstructure in the top one-fourth thickness of the tungsten/tungsten carbide layer.

The resultant product includes an outer layer of a tungsten/tungsten carbide which has a substantially layered and uniform microstructure substantially free of cracks. By viewing Figure 1A, the substantially layered microstructure of the deposit before heat treatment may be observed. It will also be noted that, although the deposit is substantially free of cracks, a somewhat non-uniform microstructure exists in the outer 25% of the tungsten/tungsten carbide layer. As may be seen in Figure 2A, the heat treatment removes this non-uniformity. Moreover, the data set out below demonstrate that the outer layer furthermore has a substantially high erosion and abrasion wear resistance than in the unheat-treated condition.

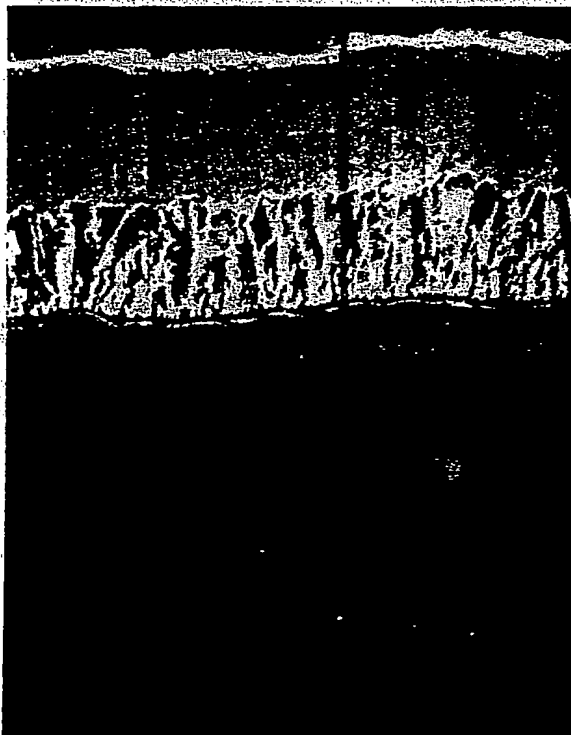
FIG. 1B

Figure 1B is a photomicrograph, magnified 2000 times, of an etched cross section of a coating system according to the invention on Ti/6Al/4V substrate in the as-deposited and unheat-treated condition showing non-uniform microstructure in the top one-fourth thickness of the tungsten/tungsten carbide layer.

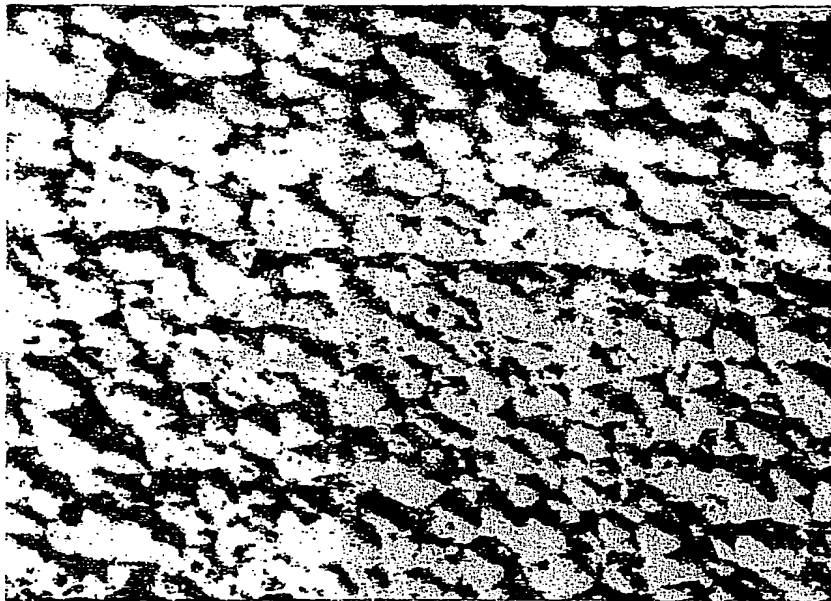
FIG. 1C

20 Figure 1C is a photomicrograph, magnified 1000 times, of a coating on AM-350 stainless steel showing the absence of cracks in the coating.

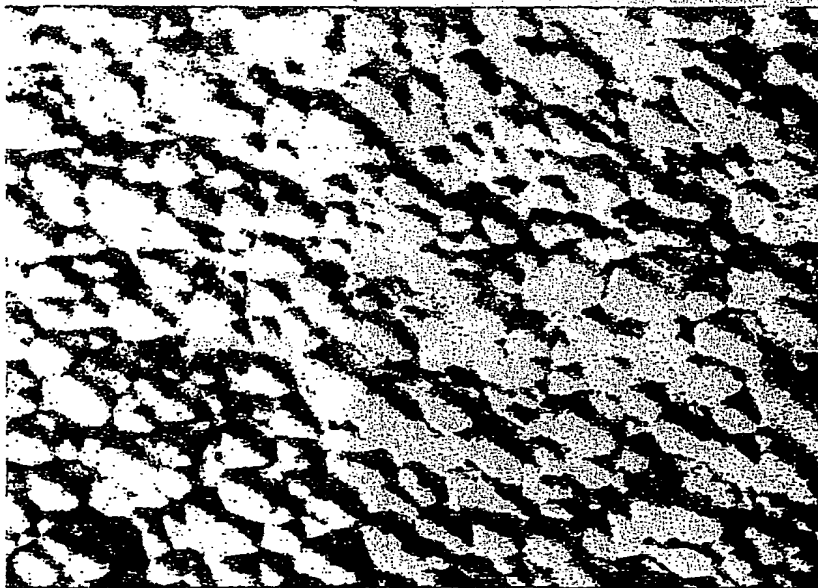
FIG. 1D

Figure 1D is a photomicrograph, magnified 1000 times, of a coating on Ti/6Al/4V showing the absence of cracks in the coating.

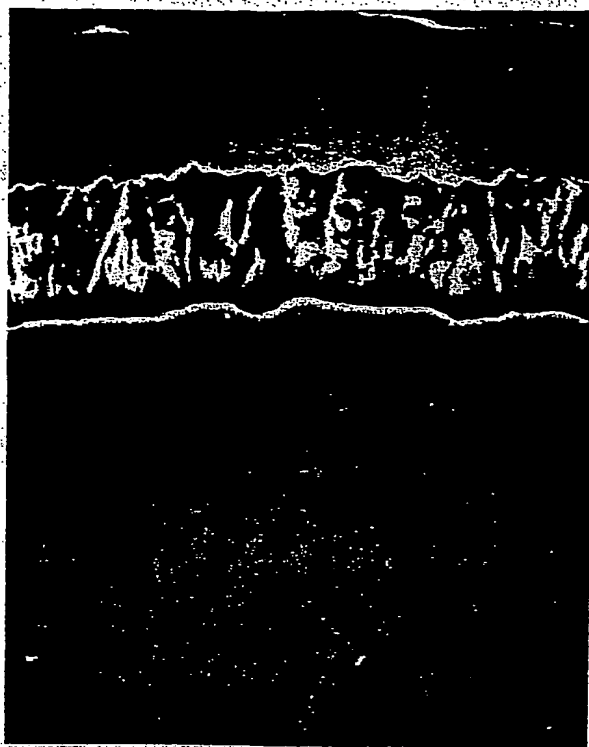
FIG. 2A

25 Figure 2A is a photomicrograph, magnified 2000 times, of an etched cross section of a coating system according to the invention on AM-350 stainless steel substrate heat treated in-situ for 60 minutes showing the absence of non-uniformity in the microstructure.

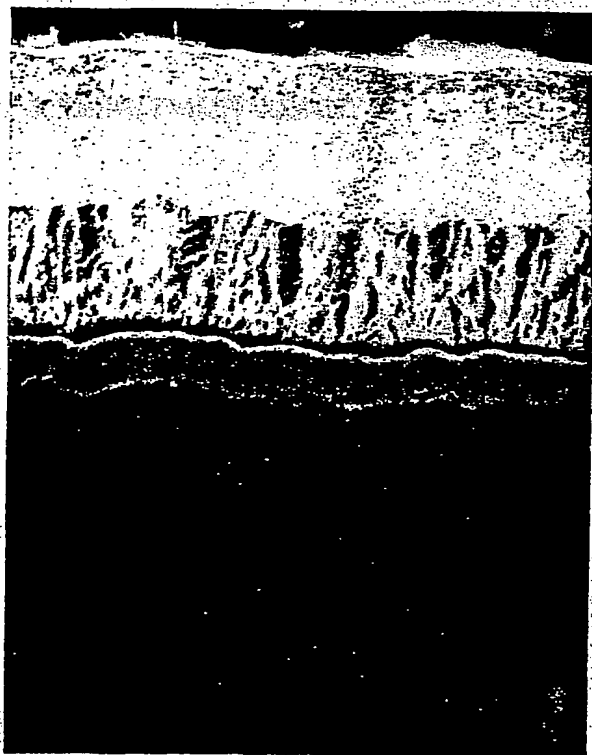
FIG. 2B

Figure 2B is a photomicrograph, magnified 2000 times, of an etched cross section of a coating system according to the invention on Ti/6Al/4V substrate heat treated in-situ for 60 minutes showing the absence of non-uniformity in the microstructure.

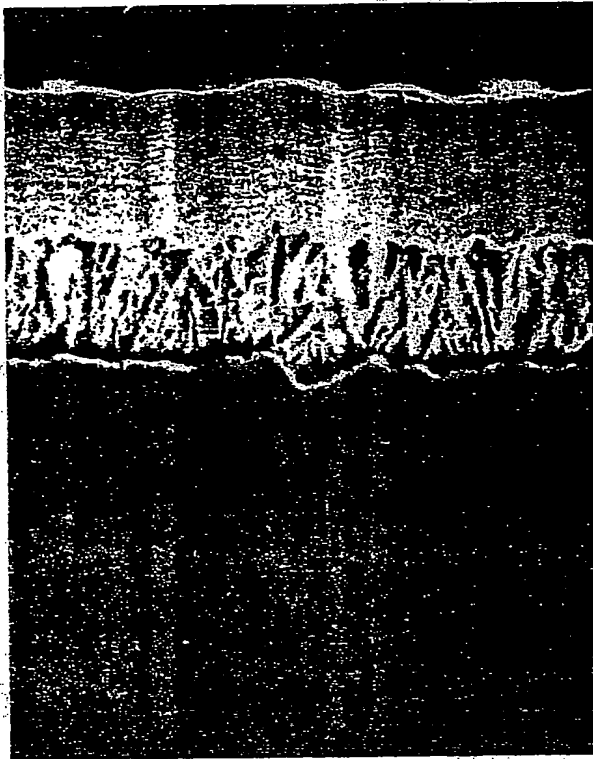
FIG. 3A

30 Figure 3A is a photomicrograph, magnified 2000 times, of an etched cross section of a coating system according to the invention on AM-350 stainless steel substrate heat treated in-situ for 120 minutes showing the absence of non-uniformity in the microstructure.

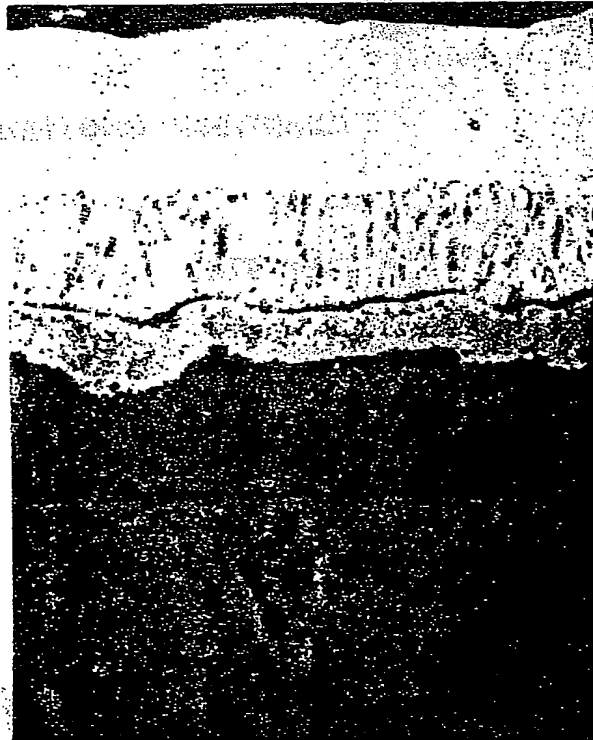
FIG. 3B

Figure 3B is a photomicrograph, magnified 2000 times, of an etched cross section of a coating system according to the invention on Ti/6Al/4V substrate heat treated in-situ for 120 minutes showing the absence of non-uniformity in the microstructure.

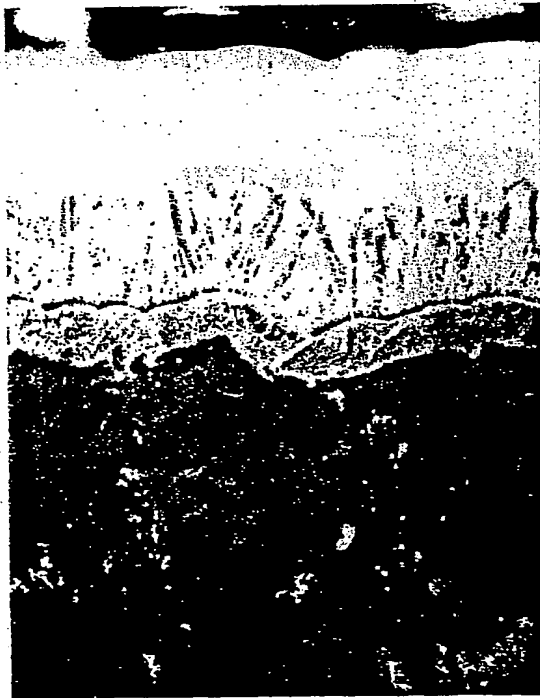
FIG. 4B

40 Figure 4B is a photomicrograph, magnified 2000 times, of an etched cross section of a coating system according to the invention on Ti/6Al/4V substrate heat treated externally for 60 minutes showing significantly reduced non-uniformity in the microstructure.

Compared to coatings with no heat treatment, coatings post heat treated for only 60 minutes in the controlled atmosphere furnace showed a dramatic reduction in the non-uniform microstructure of the tungsten/tungsten carbide layer which is revealed by etching, as shown in Figures 4A and 4B. The coating was absolutely crack-free, indicating that the post heat treatment at 475 °C, which was 15 °C higher than the deposition temperature, did not generate cracks in the coating. The surface finish of the coating was $\sim 20\mu$ inch. X-ray diffraction analysis of the heat treated coating showed no changes in the coating composition. Additionally, the hardness of the tungsten/tungsten carbide top coat did not change with the post heat treatment. The erosion resistance of the coatings on AM-350 and Ti/6Al/4V, however, improved by more than 6% (see Table 5). The erosion resistance of the coatings after 60 minutes of external heat treatment was surprisingly lower than that noted after 60 minutes of in-situ heat treatment (compare Examples 3 and 6). The differences in the improvement in the erosion insistance by in-situ and external heat treatments could be due to the use of vacuum during in-situ heat treatment as opposed to using atmospheric pressure in the external heat treatment.

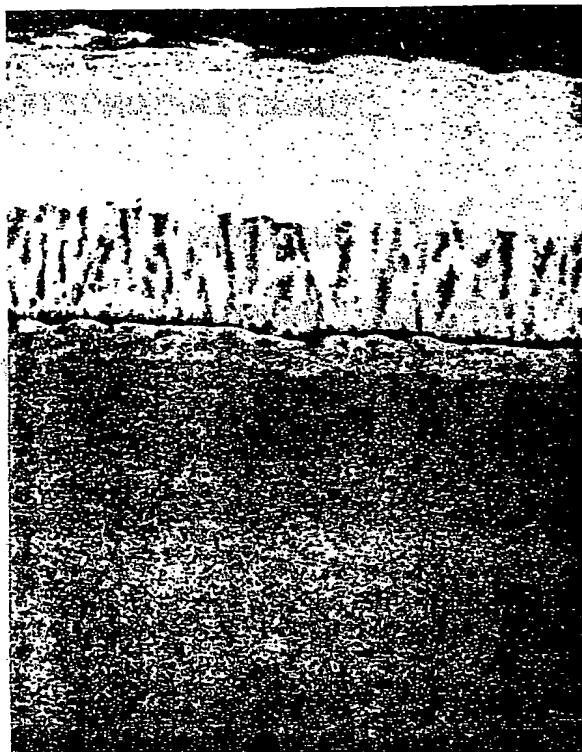
FIG. 5A

Figure 5A is a photomicrograph, magnified 2000 times, of an etched cross section of a coating system according to the invention on AM-350 stainless steel substrate heat treated externally for 1440 minutes showing the absence of non-uniformity in the microstructure.

Etched cross sections showed that the coating was microstructurally uniform after 1,440 minutes of heat treatment (see Figures 5A and 5B). No changes in coating composition and hardness, however, were noted with the post heat treatment. The erosion resistance of the coatings, on the other hand, improved by more than 13% (see Table 5). The erosion resistance of the coating on AM-350 stainless steel after 1,440 minutes of external heat treatment was very close to the value noted after 60 minutes of in-situ heat treatment. This data indicated that longer external heat treatment times were needed to match the improvements in erosion resistance noted with in-situ heat treatment. These differences,

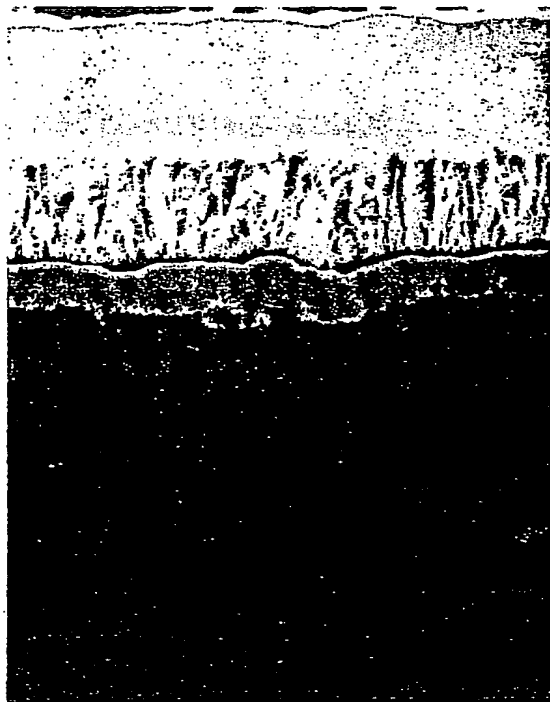
FIG. 5B

45 Figure 5B is a photomicrograph, magnified 2000 times of an etched cross section of a coating system according to the invention on Ti/6Al/4V substrate heat treated externally for 1440 minutes showing the absence of non-uniformity in the microstructure.

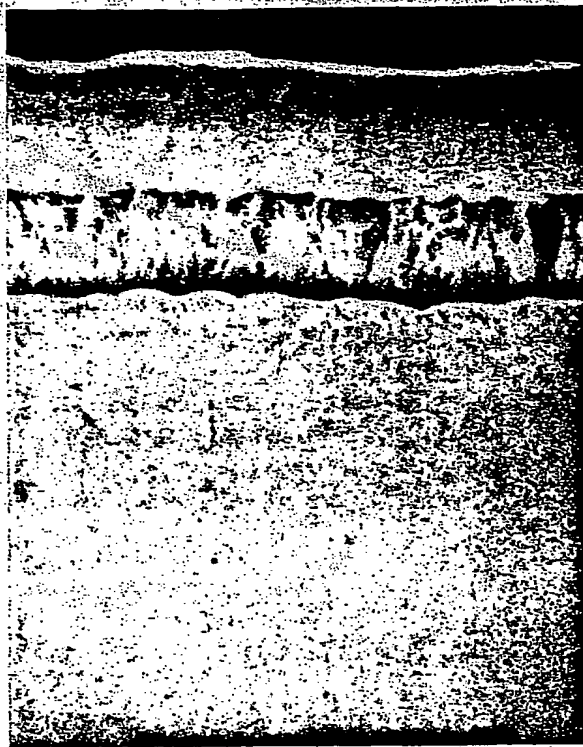
FIG. 6A

Figure 6A is a photomicrograph, magnified 2000 times, of an etched cross section of a coating system according to the invention on AM-350 stainless steel substrate heat treated in-situ for 60 minutes followed by external heat treatment for 720 minutes at 500 °C showing the absence of non-uniformity in the microstructure.

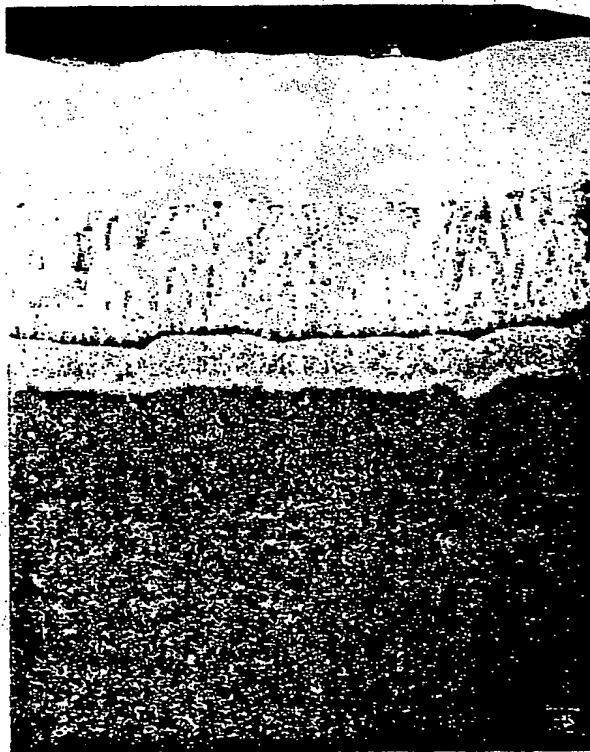
FIG. 6B

50 Figure 6B is a photomicrograph, magnified 2000 times, of an etched cross section of a coating system according to the invention on Ti/6Al/4V substrate heat treated in-situ for 60 minutes followed by external heat treatment for 720 minutes at 500 °C showing the absence of non-uniformity in the microstructure.

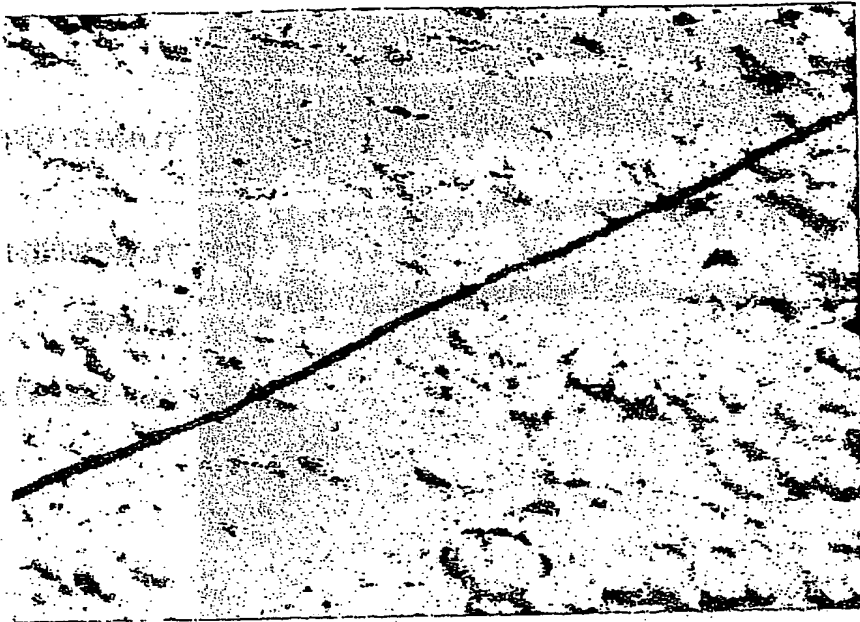
FIG. 6C

55 Figure 6C is a photomicrograph, magnified 1000 times, of a coating on AM-350 stainless steel substrate heat treated in-situ for 60 minutes followed by external heat treatment for 720 minutes at 500 °C showing cracks in the coating.

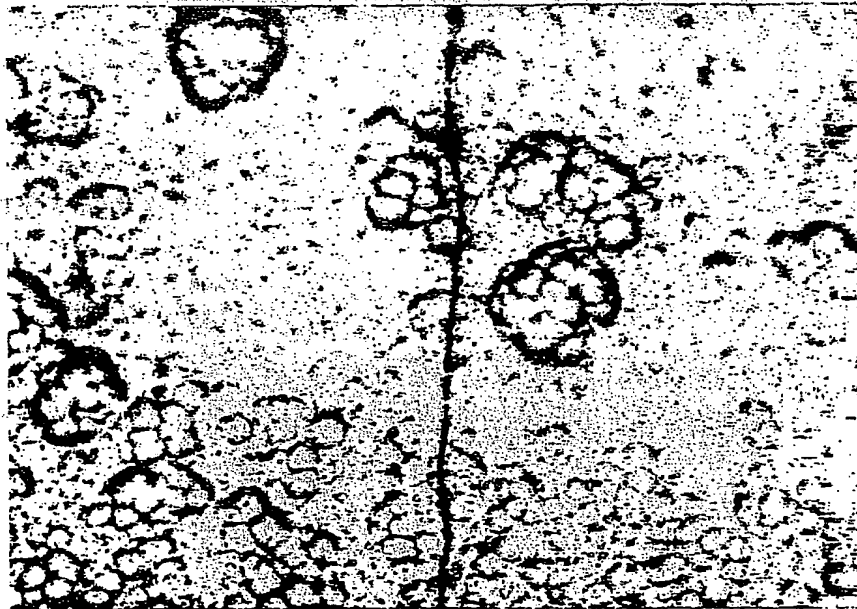
FIG. 6D

Figure 6D is a photomicrograph, magnified 1000 times, of a coating on Ti/6Al/4V substrate heat treated in-situ for 60 minutes followed by external heat treatment for 720 minutes at 500 °C showing cracks in the coating.

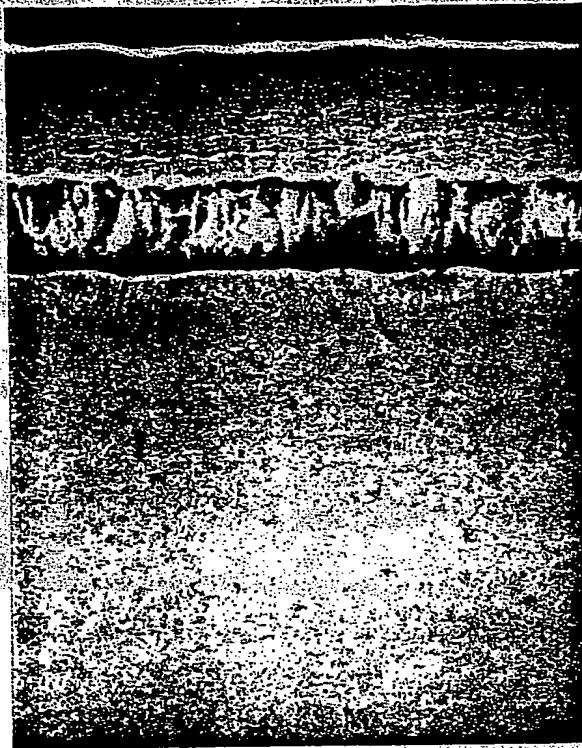
FIG. 7A

Figure 7A is a photomicrograph, magnified 200 times, of an etched cross section of a coating system according to the invention on AM-350 stainless steel substrate heat treated in-situ for 60 minutes followed by external heat treatment for 720 minutes at 550 °C showing the absence of non-uniformity in the microstructure.

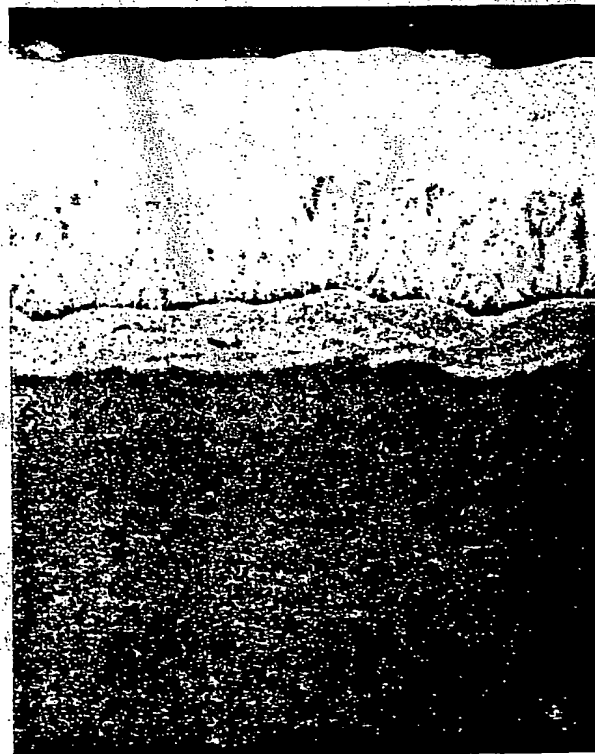
FIG. 7B

Figure 7B is a photomicrograph, magnified 2000 times, of an etched cross section of a coating system according to the invention on Ti/6Al/4V substrate heat treated in-situ for 60 minutes followed by external heat treatment for 720 minutes at 550 °C showing the absence of non-uniformity in the microstructure and the formation of an intermetallic titanium-nickel compound.

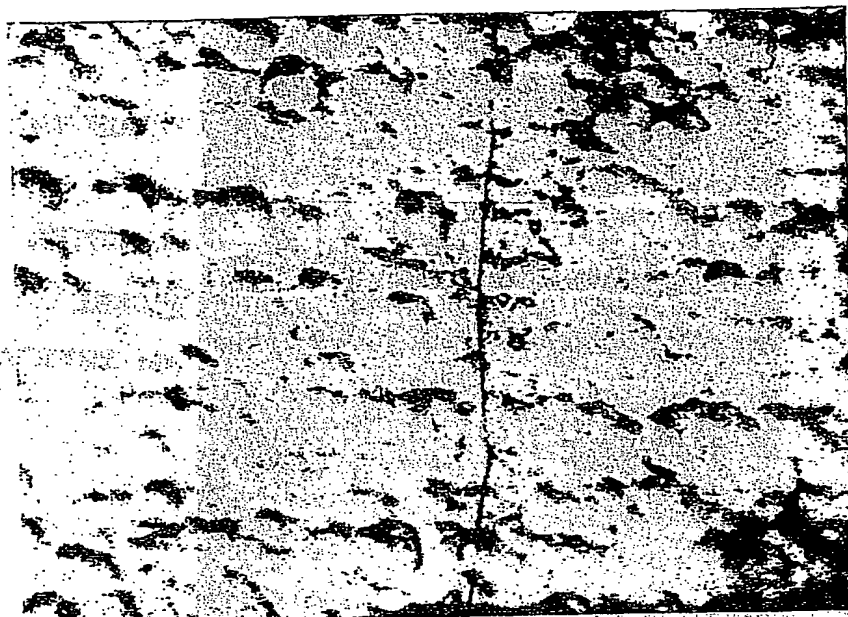
FIG. 8A

Figure 8A is a photomicrograph, magnified 1000 times, of a coating on AM-350 stainless steel substrate heat treated in-situ for 60 minutes followed by external heat treatment for 720 minutes at 600 °C showing cracks in the coating.

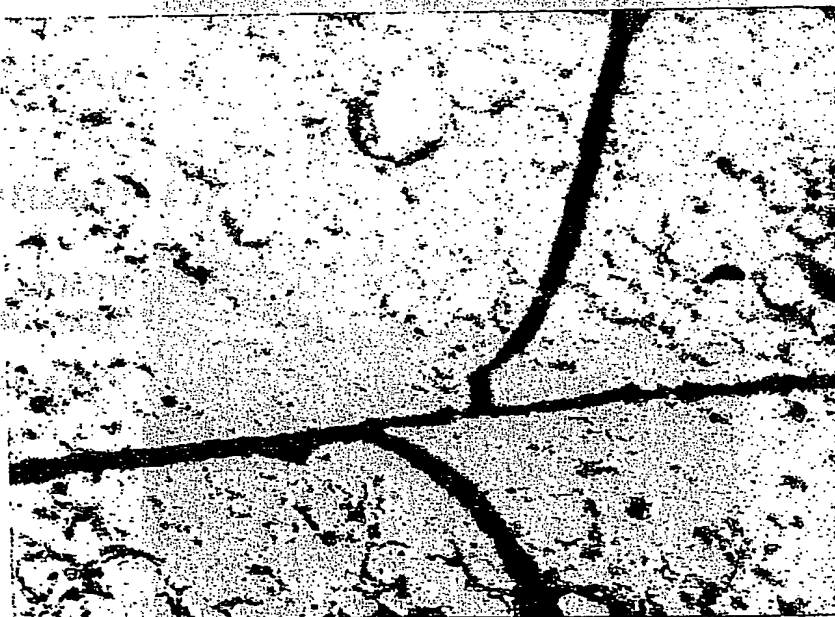
FIG. 8B

Figure 8B is a photomicrograph, magnified 1000 times, of a coating on Ti/6Al/4V substrate heat treated in-situ for 60 minutes followed by external heat treatment for 720 minutes at 600 °C showing cracks in the coating.

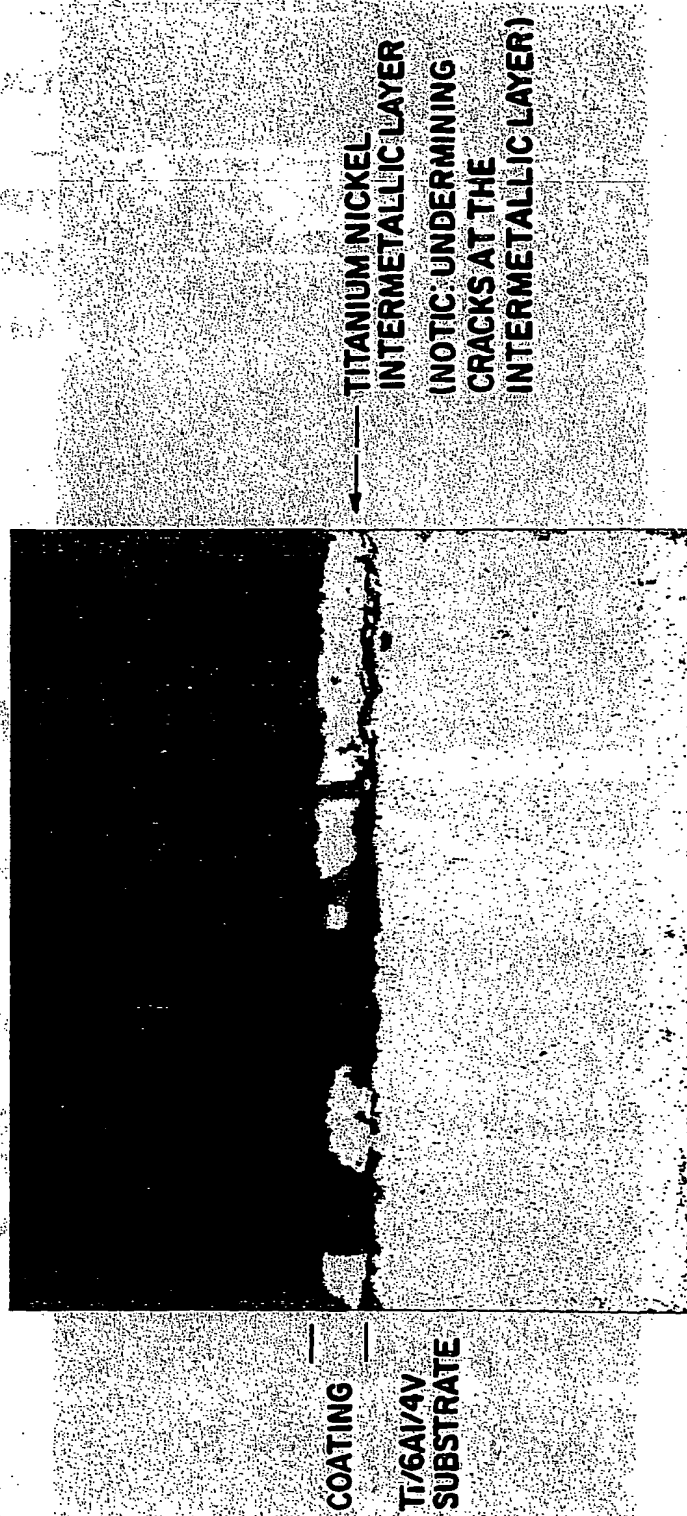
FIG. 9

Figure 9 is a photomicrograph, magnified 500 times, of a cross section of a coating system on Ti/6Al/4V substrate heat treated in-situ for 60 minutes followed by external heat treatment for 720 minutes at 600 °C showing the failure of the coating during the erosion test.
